# Manhole Inspection Summary

Manhole # S23GG1015MH

Insp Date: **12/7/06 1:18 PM**

**Location** Address: **1401 WELDON PL**

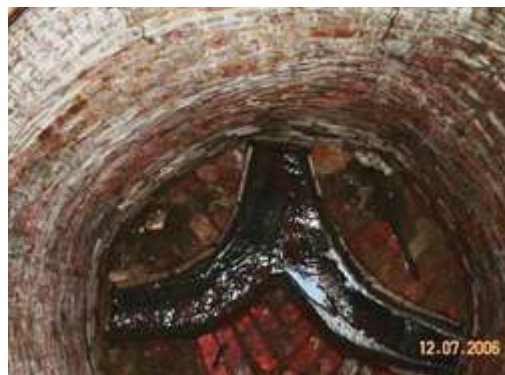
Top View

**Bench** ☒ Exists Material: **Brick** ☐ Parged ☒ **Debris** (not Condition related)

Bench debris.

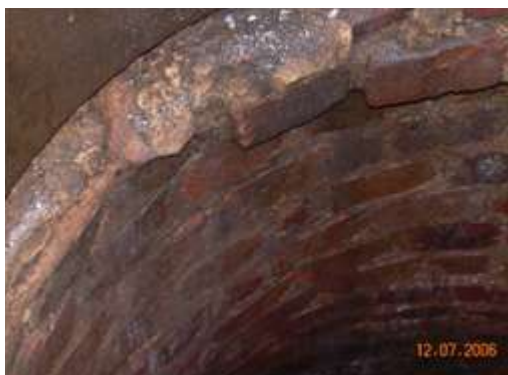
Defect

**Frame** Offset: **2** (in.) Condition: ☒ Sound ☐ Cracked ☐ Leaks

Condition: ☐ Sound ☐ Cracked ☐ Root Intrusion ☐ Loose Brick ☒ **Deteriorated**

Infiltration: ☐ None ☒ **Joint** ☐ Cracks ☒ **Mortar** ☐ Roots ☐ Wall

Frame offset. Adjustment deterioration and infiltration.

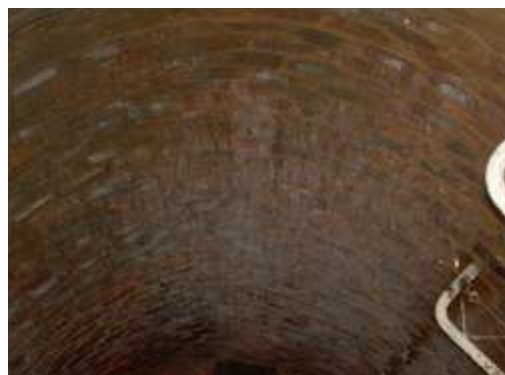
Defect

Infiltration: ☐ None ☐ Joint ☒ **Cracks** ☒ **Mortar** ☐ Roots ☒ **Wall**

Barrel infiltration.

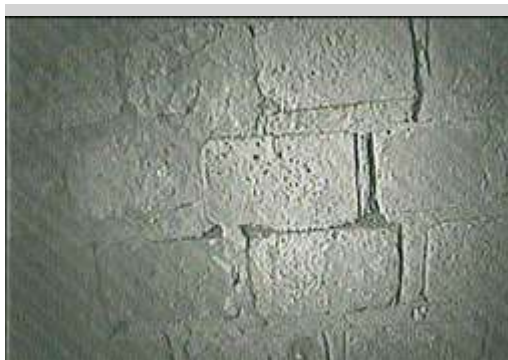
Defect

Condition: ☐ Sound ☒ **Cracked** ☐ Root Intrusion ☐ Loose Brick ☐ Deteriorated

Barrel cracks and infiltration.

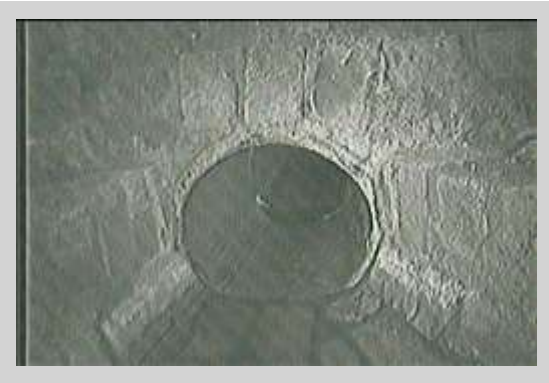
### 8 in. Circular Gravity Sewer Pipe Out @ 12 O'Clock

Infiltration: **None** Pipe Seal Cond: **Sound**

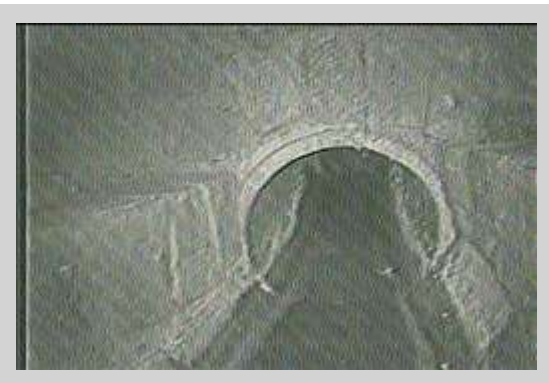
### 8 in. Circular Gravity Sewer Pipe In @ 3 O'Clock

Infiltration: **None** Pipe Seal Cond: **Sound**

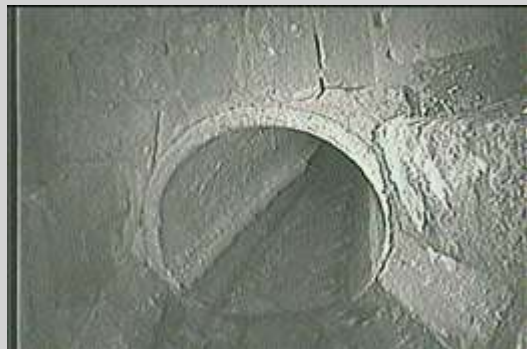
Pipe In @ 9 O'Clock

Infiltration: **None**

Pipe Seal Cond: **Sound**
